Grounding of HVAC Motor Shafts Protects Bearings, Lowers Repair Costs

WHITE PAPER:
Grounding of HVAC Motor Shafts Protects Bearings, Lowers Repair Costs

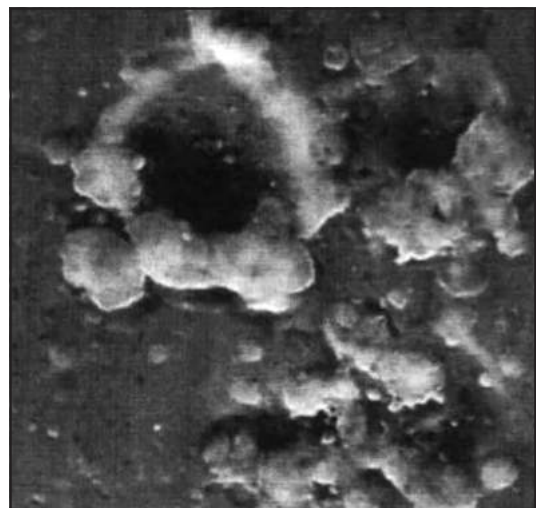
Figure 1

Pitting of a bearing race wall (magnified) — the result of VFD-induced electrical discharges from the motor shaft.

Continued discharges result in the pitting [Figure 1] of the balls and race walls through electrical discharge machining (EDM). Concentrated pitting at regular intervals along the race wall can cause washboard-like ridges called fluting [Figure 2], a source of vibration and noise that can reverberate through ductwork. By the time such damage can be heard, bearing failure is often imminent.

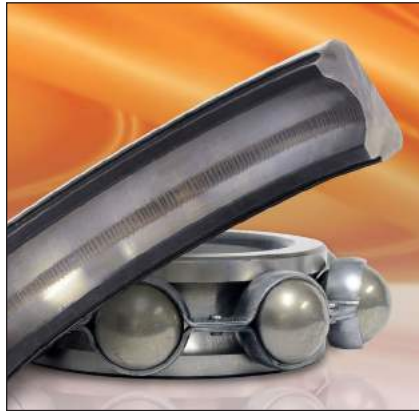
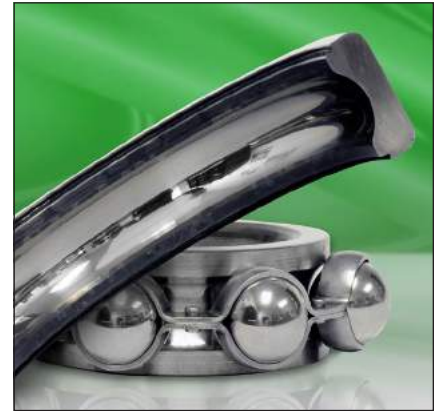
Figure 2

Taken from a failed motor, the “fluted” bearing race wall (left) resulted from VFD-induced bearing currents. Protected by an AEGIS® Bearing Protection Ring, the bearing race on the right is undamaged.

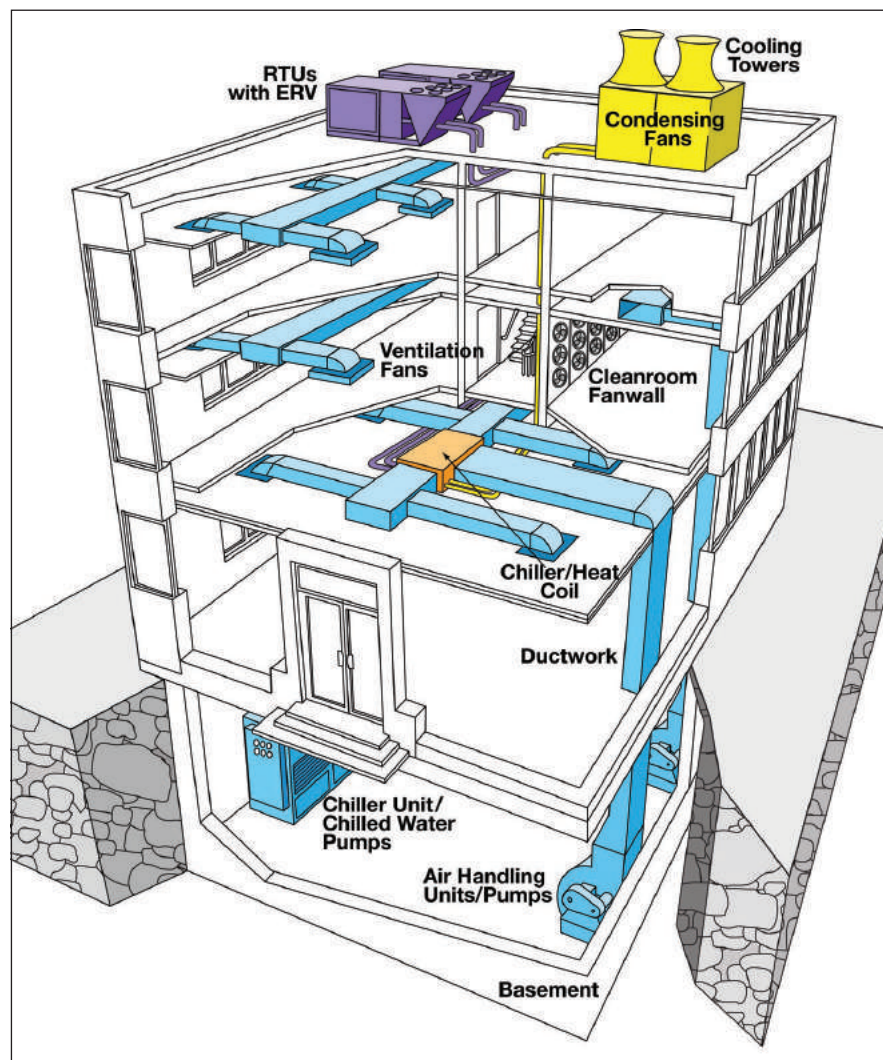
Figure 3

To save energy and help make buildings "green," the AC motors in many types of HVAC equipment today are controlled by variable frequency drives and thus are vulnerable to bearing damage. This diagram shows some of these applications where shaft grounding makes motors and systems sustainable as well as energy-efficient.

AEGIS® Rings have been proven in millions of installations worldwide. HVAC applications for the rings include rooftop systems, indoor and outdoor air handling units, ventilation fans, fan walls, air- or water-cooled chillers, chilled water and other pumps, condensing fans, and compressors [Figure 3].

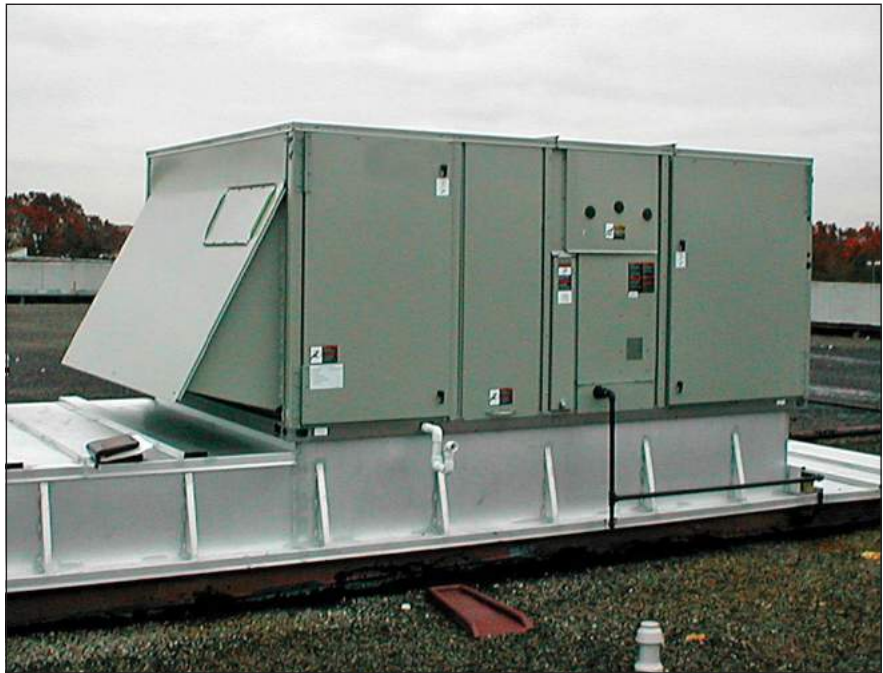
Figure 4

Rooftop HVAC unit in Michigan where a newly installed AEGIS® Bearing Protection Ring reduced shaft currents by 92% to levels well below those that damage bearings.

Electro Static Technology (EST), manufacturer of AEGIS® Rings, recently demonstrated the effectiveness of the rings on a rooftop air conditioning unit typical of those installed on commercial buildings. In one such packaged rooftop HVAC unit [Figure 4] a VFD-controlled motor runs a belt-driven fan. EST technicians took voltage readings from the motor using a voltage probe and a portable oscilloscope — both before and after installing an AEGIS® Ring on the motor's shaft.

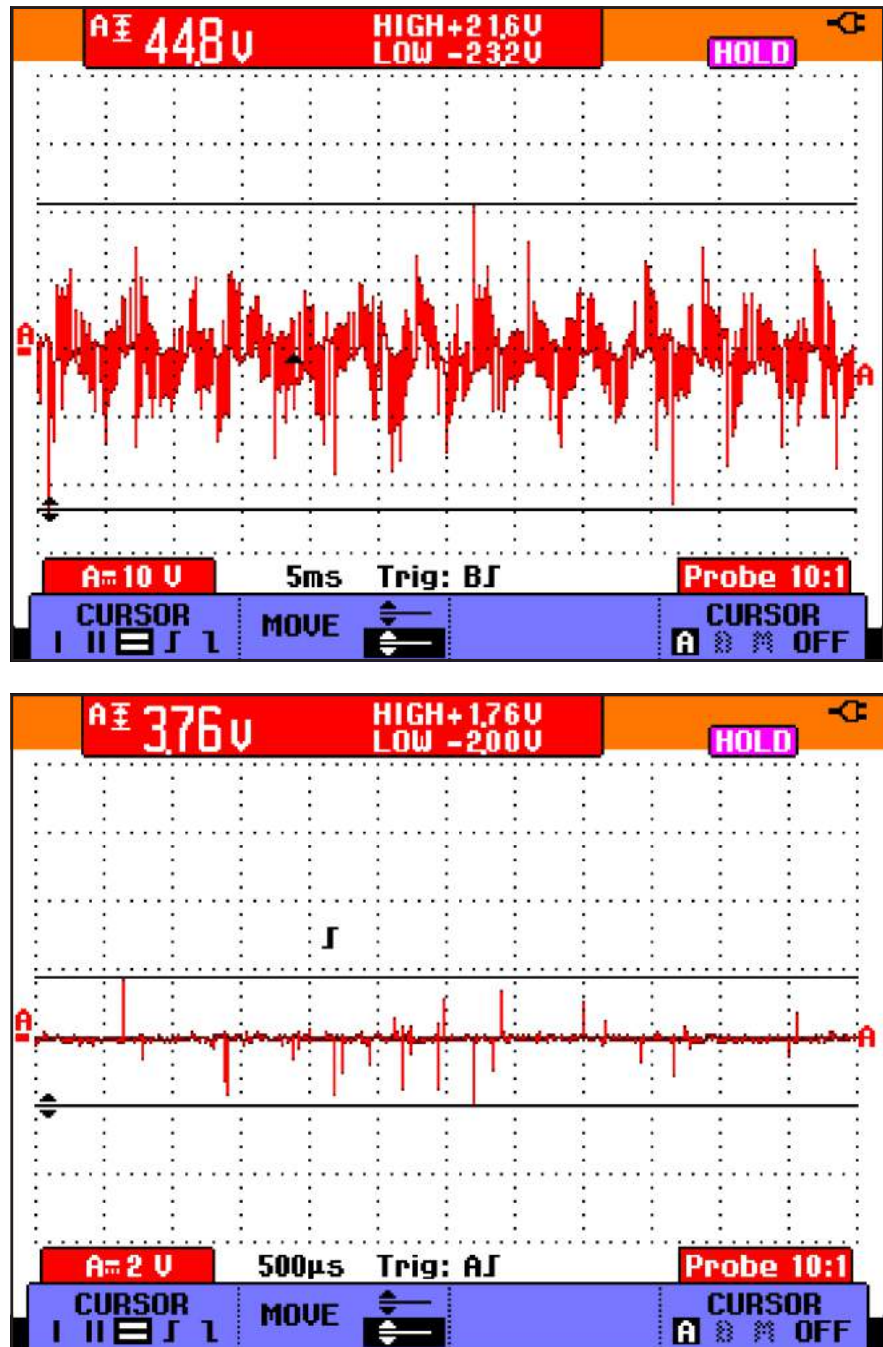
Figure 5

Motor shaft voltage readings before (top) and after (bottom) installation of the AEGIS® Bearing Protection Ring on a motor in an HVAC unit on the roof of a Michigan department store. The AEGIS® Ring reduced peak-to-peak shaft voltage from 44.8V to a safe level of 3.76V.

In a continuous 60- μ sec trace (oscilloscope settings: 10v/div, 5 msec/div) with the motor running at 3,600 rpm (80 Hz output), discharges from the shaft were 44.8 volts peak-to-peak, high enough to cause pitting of the motor's bearings. After the AEGIS® Shaft Grounding Ring was installed, a follow-up test at 3,600 rpm (oscilloscope settings: 2v/div, 500 μ sec/div) showed that discharges had dropped to only 3.76 volts peak-to-peak [Figure 5], well below levels that damage bearings.

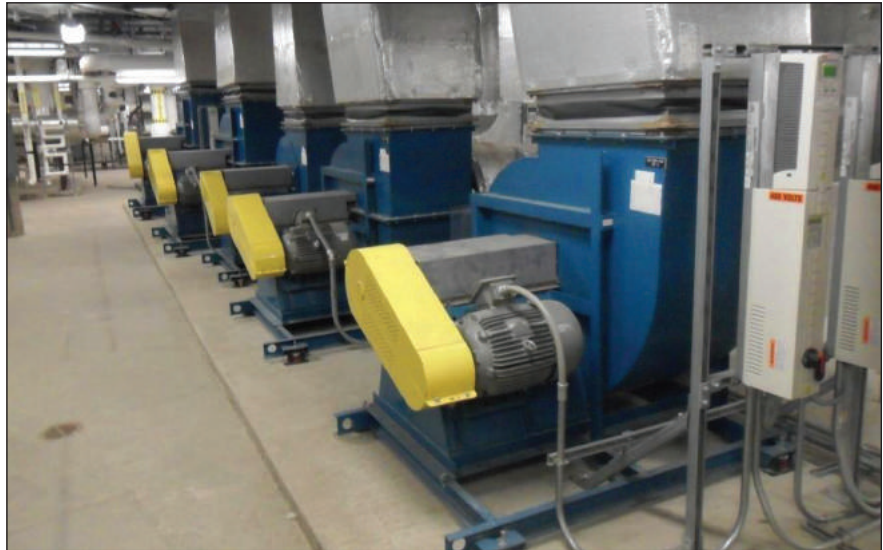
Figure 6

Installed on a VFD-controlled motor in an air handling unit at a community hospital in suburban Chicago, an AEGIS® Bearing Protection Ring reduced harmful shaft currents by 83% to levels well below those that damage bearings.

This time, the motor was in the building's basement. The TECO 254T 3-phase TEFC motor, controlled by a 480-volt VFD (60Hz output), runs a fan in an air handling unit for several operating rooms [Figure 6]. EST technicians first used a voltage probe and oscilloscope to confirm that VFD-induced voltages were indeed building up on the motor shaft and discharging through the bearings at spikes high enough to cause pitting. The peak-to-peak reading was 11.4 volts (oscilloscope settings: 2v/div, 200 µsec/div).

Follow-up readings after the AEGIS® Ring was installed showed that the ring had lowered shaft voltage discharges by 83%.

Because the ring was by now effectively channeling harmful shaft currents away from bearings to ground, the new peak-to-peak reading was negligible (1.92 volts), too low to damage bearings (oscilloscope settings: 2 v/div, 100 μ sec/div).

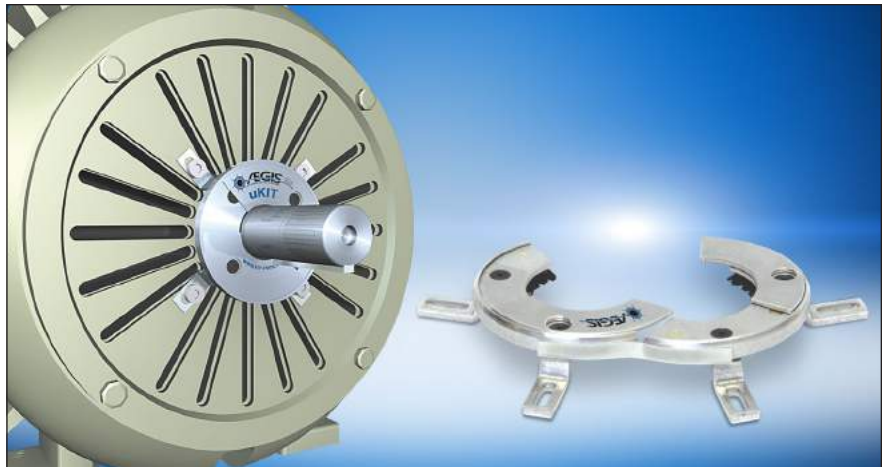
Figure 7

The Universal Mounting Kit includes brackets and hardware that simplify mounting of an AEGIS® Bearing Protection Ring.

EST has recommended that the hospital install AEGIS® Rings on all of its VFD-driven motors to prevent future bearing damage. The ring can be installed on either end of the motor, but the simplest installation is to slide the ring over the drive end of the shaft and fasten it to the end bell. This can be easily accomplished using the new AEGIS® Universal Mounting Kit (uKIT) [Figure 7], which simplifies mounting on virtually any AC motor shaft. The kit includes the proven AEGIS® Shaft Grounding Ring, brackets, and hardware.

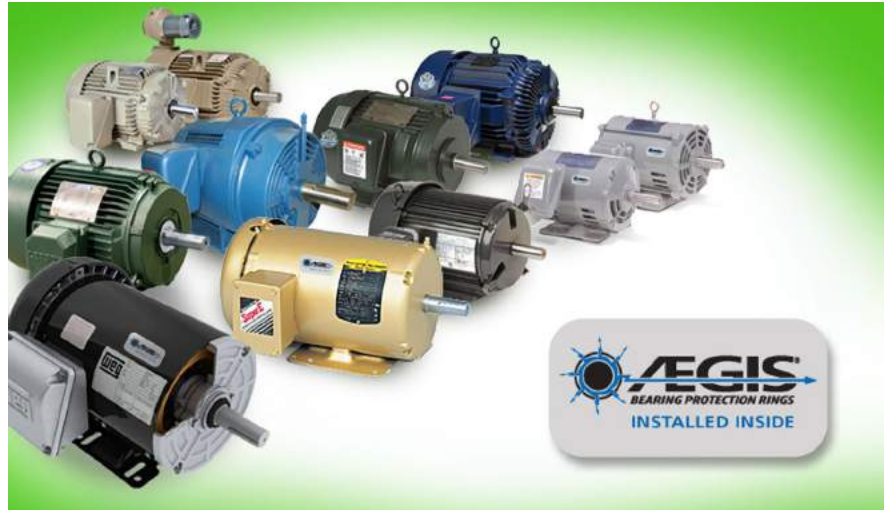
Figure 8

A large and growing number of motor manufacturers now offer motors with AEGIS® Rings factory installed either outside or inside their motors.

While retrofits are still the most common way to protect bearings from VFD-induced shaft voltages, a large and growing number of OEMs are now offering motors with AEGIS® Shaft Grounding Rings factory installed [Figure 8].
