To Be Considered “True Inverter-Duty”, Motors Need Bearing Protection

by Adam Willwerth
Development Manager, Electro Static Technology

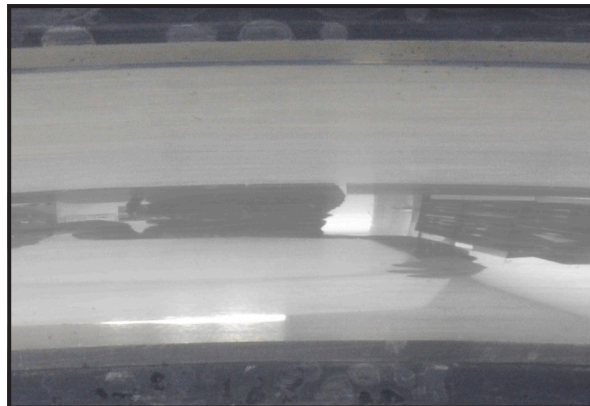
Figure 1: A new bearing race wall has a mirror-smooth surface to minimize friction.

Bearings, which normally have mirror-smooth surfaces [Figure 1], can become damaged by electrical discharges. Without some form of mitigation, shaft currents discharge through bearings, causing unwanted electrical discharge machining (“EDMing”) that erodes the bearings and race walls [Figure 2] and leads to premature bearing/motor failure. Before long, these frequent discharges can leave the entire bearing race riddled with pits known as frosting.

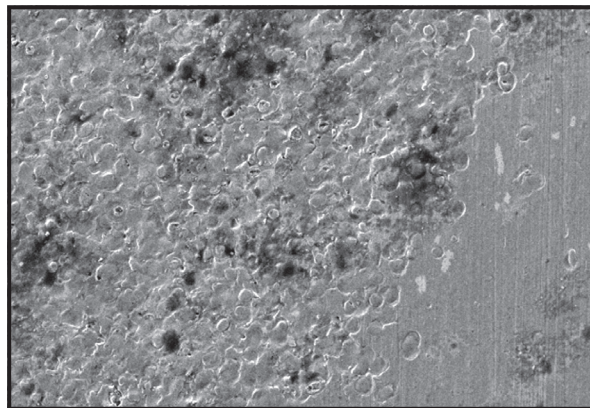
Figure 2: Pitting of a bearing race wall (magnified) is the result of electrical discharge machining (EDM) as shaft currents discharge through the bearings, blasting small craters in metal surfaces.

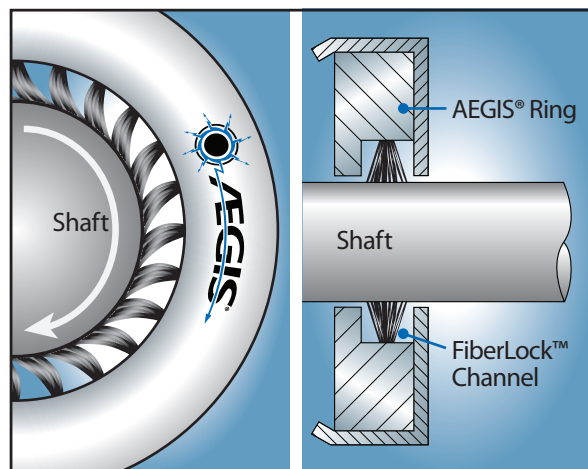
Figure 4: Unlike discrete-point brushes, AEGIS® rings have rows of microfibers that surround the shaft 360°. They are secured in place by a patented FiberLock™ Channel, allowing them to flex without breaking.

Unlike older single-point contact brushes, new grounding rings encircle a motor’s shaft with contact points for far greater effectiveness. AEGIS® Bearing Protection Rings have continuous circumferential rows of specially engineered microfibers (secured in a patented FiberLock™ channel) that boost electron transfer rates and provide a very low impedance path from shaft to frame [Figure 4]. These rings safely bleed damaging currents to ground, bypassing a motor’s bearings entirely. And because the microfiber brushes work with little or no contact, they do not wear out like conventional brushes. In fact, AEGIS® grounding rings have been proven effective in over a million installations worldwide.

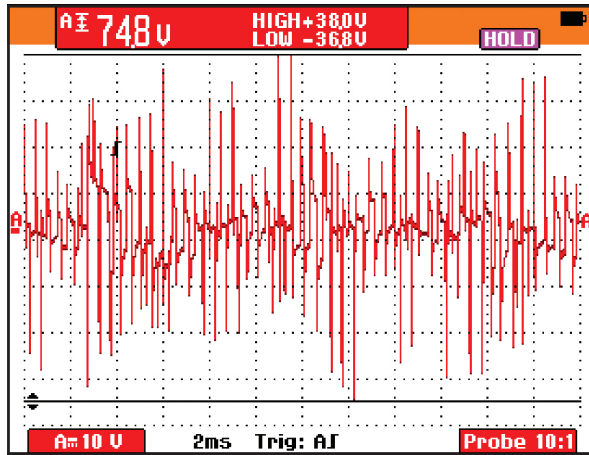
Figure 5: Measured with an oscilloscope, shaft currents on an HVAC motor without shaft grounding.

redirecting currents from shaft to ground [Figure 5]. Easily installed at the factory or retrofitted later [Figure 6], it makes VFD-controlled systems sustainable by protecting motor bearings from catastrophic failure.

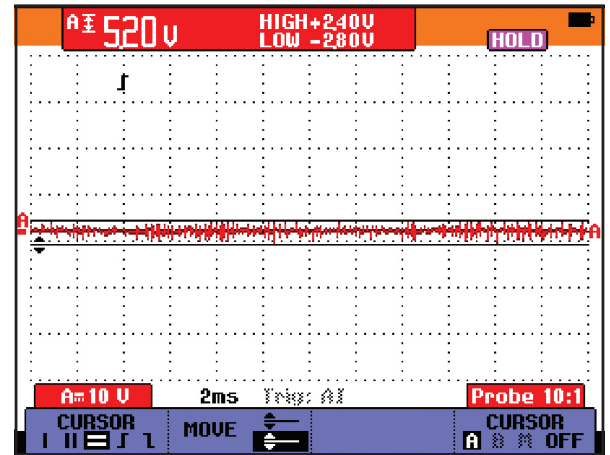
Motor shaft currents on the same HVAC motor after installation of an AEGIS® Bearing Protection Ring.

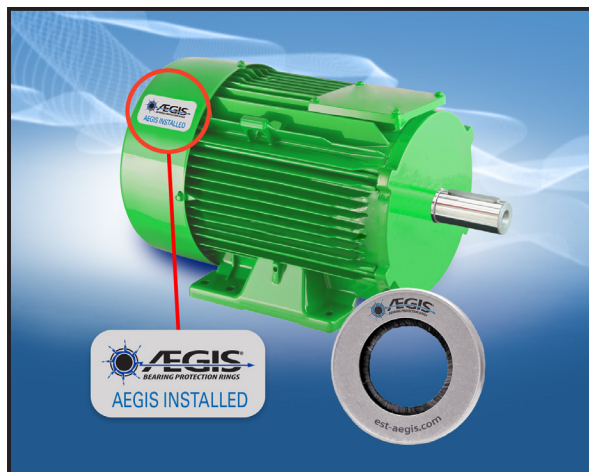
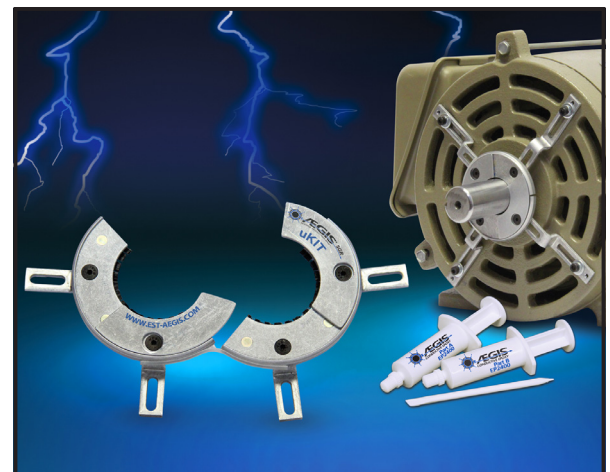
Figure 6: AEGIS® Bearing Protection Rings are available for any size NEMA or IEC motor. They can be factory-installed inside or outside a new motor or quickly and easily retrofitted — even in the

field — using conductive epoxy. A new Split uKIT simplifies and speeds mounting of the ring on motors with shaft shoulders, slingers, or other end-bell protrusions.

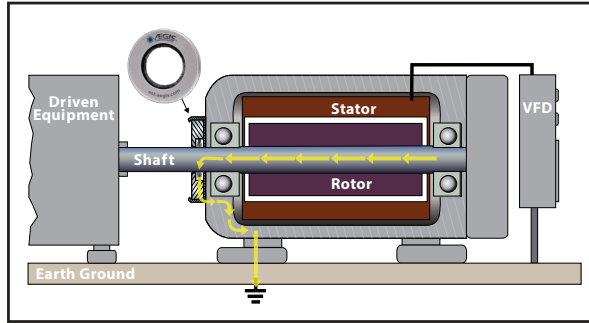
Figure 7: For motors up to and including 100HP, a shaft grounding ring should be installed on the drive end on the motor shaft—either inside or outside the motor.

For motors up to 100HP, where common mode voltages could cause bearing damage, adding a shaft grounding ring to the motor, either internally or externally, provides effective protection against bearing currents for motor bearings as well as attached equipment [Figure 7].

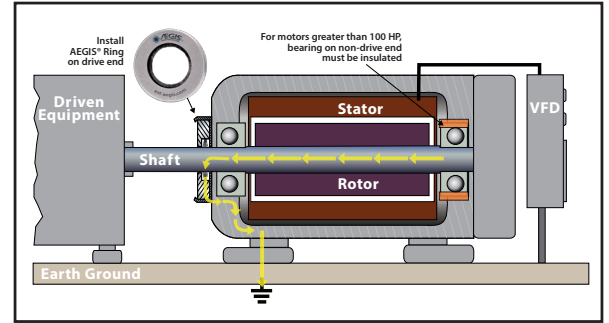
Figure 8: For motors greater than 100HP, a shaft grounding ring should be installed on the drive end of the motor shaft, and the bearing on the non-drive end should be isolated with an insulation sleeve or ceramic bearings.

For motors greater than 100HP, where both circulating currents and common mode voltages could cause bearing damage, combining an insulated bearing on one end with a shaft grounding ring on the opposite end provides the best protection from electrical bearing damage [Figure 8].
